INDOOR AIR QUALITY ASSESSMENT

**Goodrich Academy
111 Goodrich Street
Fitchburg, MA**

Prepared by:
Massachusetts Department of Public Health
Bureau of Environmental Health
Indoor Air Quality Program
February 2020

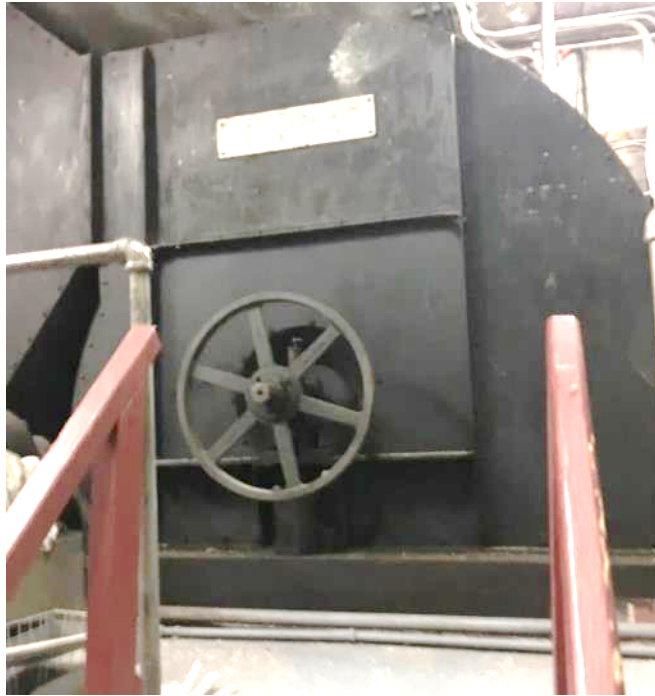
Picture 1

The building has two types of ventilation systems. Fresh air was originally provided by an air handling unit (AHU) located in a large room in the basement (Picture 1). The deactivated AHU used a motor to power a large fan using a fan belt, which was found removed at the time of the assessment. The amount of fresh air drawn into the AHU room is controlled by a door/window which was found sealed. When the system was functioning as designed, fresh air would be mixed in this room prior to being drawn into the heating elements via the air handler. Ductwork connects this AHU to air diffusers (Picture 2) throughout the building.

Abandoned HVAC system equipment in the basement

1. Consideration should be given to replace HVAC units/components as they become past their service life. If not conducted already, consider contacting an HVAC engineering firm for an assessment of the ventilation system’s components and control systems (e.g., controls, air intake louvers, thermostats). Based on the age, physical deterioration, and availability of parts for ventilation components, such an evaluation is necessary to determine the operability and feasibility of repairing/replacing the equipment.

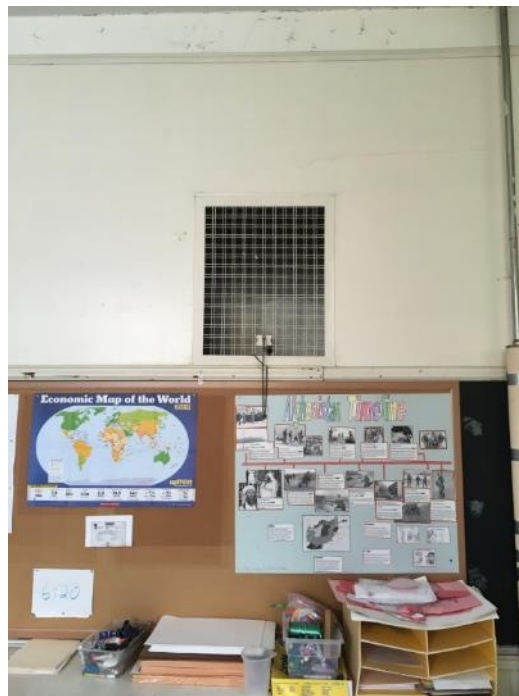
Picture 2

Original fresh air supply vent

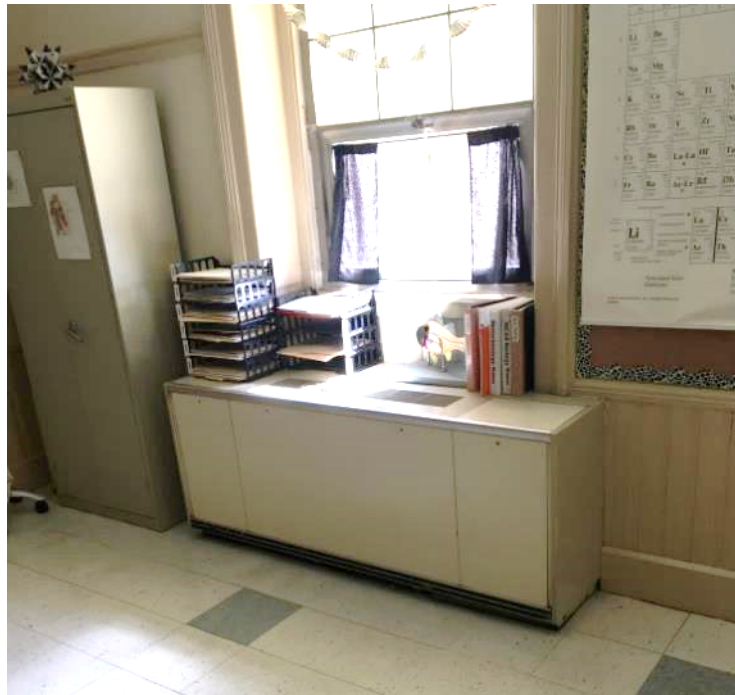
Picture 3

Some classrooms are equipped with unit ventilators (univents) (Picture 3). Univents draw air from the outdoors through a fresh air intake located on the exterior wall of the building and return air from the room through an air intake located at the base of the unit. Fresh and return air are mixed, filtered, heated or cooled and provided to rooms through an air diffuser located in the top of the unit ([Figure 1](#)). In some rooms items were on top or in front of univents, which can interfere with air circulation. Exhaust ventilation is provided by wall-mounted air shafts (Picture 4). Without proper supply and exhaust ventilation, common indoor air pollutants can build up and lead to IAQ/comfort complaints.

With regard to HVAC system function, according to the American Society of Heating, Refrigeration and Air-Conditioning Engineers (ASHRAE), the service life for a unit heater, hot water or steam is 20 years, assuming routine maintenance of the equipment (ASHRAE, 1991). Despite attempts to maintain the univents (e.g., oiling bearings, changing filters regularly), the operational lifespan of this equipment has been exceeded in all areas of the GA. Maintaining the balance of fresh to exhaust air will become more difficult as the equipment ages and as replacement parts become increasingly difficult to obtain.

Unit ventilator (univent)

8. After consulting with a ventilation engineer, examine the feasibility of changing filters in operating HVAC units at least twice a year with Minimum Efficiency Reporting Value (MERV) 8 (or higher) filters. Clean HVAC and univert cabinets of debris and dust when filters are changed.

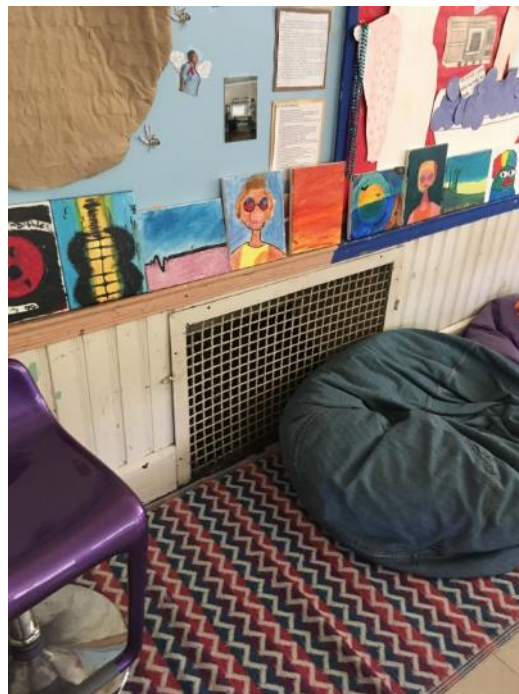
Picture 4

Exhaust vent

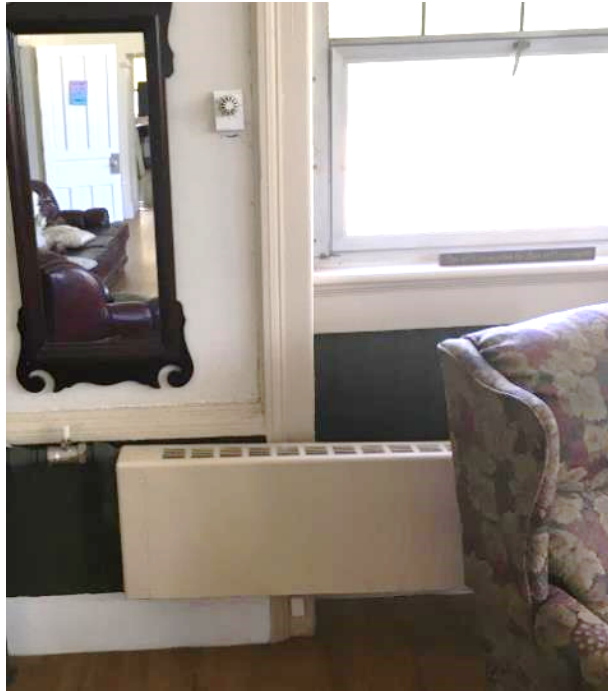
Picture 5

MDPH staff received numerous complaints concerning heat control in this building. The lack of heat control is in part due to the condition of the mechanical ventilation system. In addition, the location of thermostats likely contributes to poor temperature control. In order to provide adequate thermal comfort, thermostats are typically located near exhaust vents to measure temperature in a room. However, some thermostats in the GA were located on exterior

walls over radiators or exposed heating pipes (Picture 5). In this configuration, the thermostats would measure heat from radiators and heating pipes and deactivate the heating before rooms are comfortable. In addition, as shown in Picture 5, some thermostats are located on exterior walls near windows. Since the building was constructed in 1891, the exterior walls were constructed without insulation. Without insulation, exterior walls are subject to seasonal temperature extremes (e.g., cold in winter, warm in summer). Thermostats attached to a chilled wall will unnecessarily call for heat, leading to overheating.

Thermostat on exterior wall with window and above radiator

2. In order to better control heating in the building, relocating thermostats to interior walls to give appropriate air temperature measurements in highly recommended.

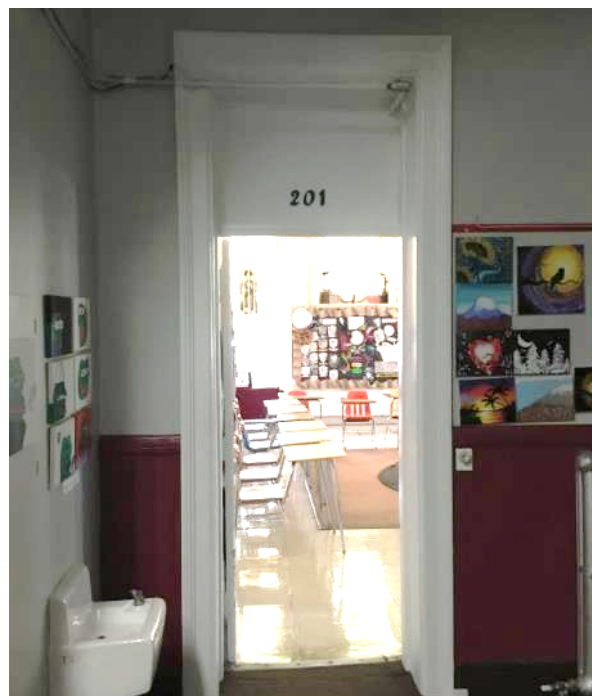
Picture 6

The building appears to be originally designed to provide comfort in warm weather by opening windows and using cross-ventilation. The building was likely originally equipped with windows on opposing exterior walls along with hinged windows (called transoms, Picture 6) located above the doors between classrooms and the hallways. A transom enables the classroom doors to be closed while maintaining a pathway for airflow. This design allows for airflow to enter an open window, pass through a classroom, pass through the open transom, enter the hallway, pass through the opposing open classroom transom, into the opposing classroom and exit the building on the leeward side (opposite the windward side) ([Figure 2](#)). With all windows and transoms open, airflow can be maintained in a building regardless of the direction of the wind. The system fails if the windows or transoms are closed ([Figure 3](#)). All transoms in the building were found to be sealed, which prevents cross-ventilation as originally designed.

Area that appears to be a sealed/replaced transom over hallway door

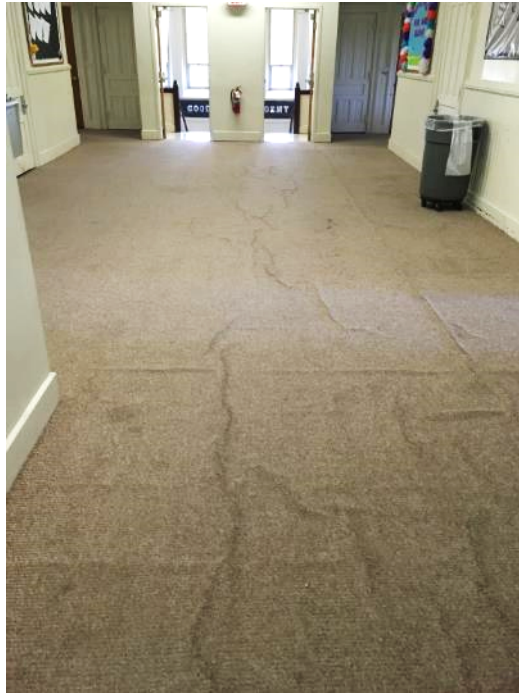
Picture 7

Carpeting on the first and second floors was found stained or rippling (Pictures 7 and 8; Table 1). This carpeting is likely past its service life. The service life of carpeting in schools is approximately 10-11 years (IICRC, 2002). Aging carpet can produce fibers that can be irritating to the respiratory system. In addition, tears or lifting carpet can create tripping hazards. Carpeting should be cleaned annually or semi-annually in soiled high traffic areas as per the recommendations of the Institute of Inspection, Cleaning, and Restoration Certification (IICRC, 2012).

Rippled carpeting

3. Consider removing water-damaged, musty, or worn carpeting. Replace with non-porous materials if possible. Before removal, please assess whether carpeting is adhered to asbestos-containing floor tile. If so, please remove carpet in a manner consistent with Massachusetts Asbestos laws and regulations.

11. Clean carpeting annually or semi-annually in soiled high traffic areas as per the recommendations of the Institute of Inspection, Cleaning and Restoration Certification (IICRC 2012).

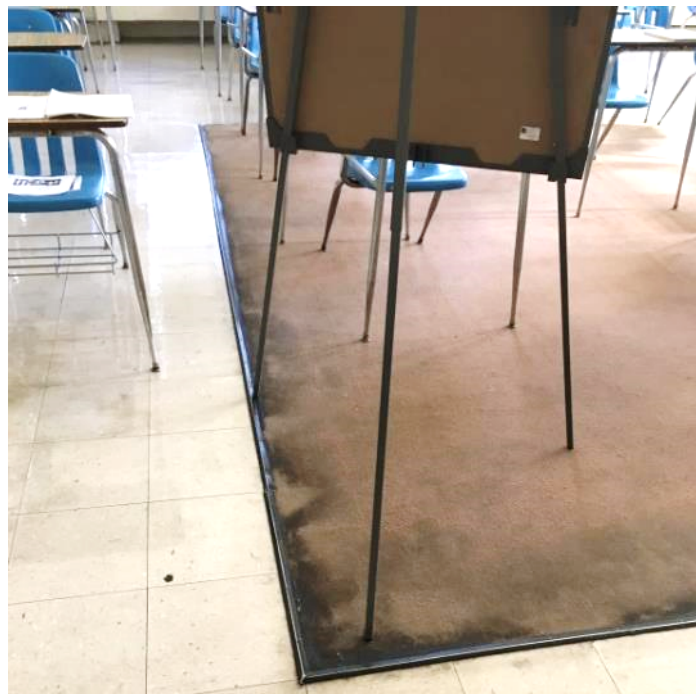
Picture 8

Discolored carpeting
